**Roosevelt County/Fort Peck Reservation
Tornado Event July 15, 2013
National Weather Service Glasgow
Storm Survey Summary – Update #2 July 17, 2013**

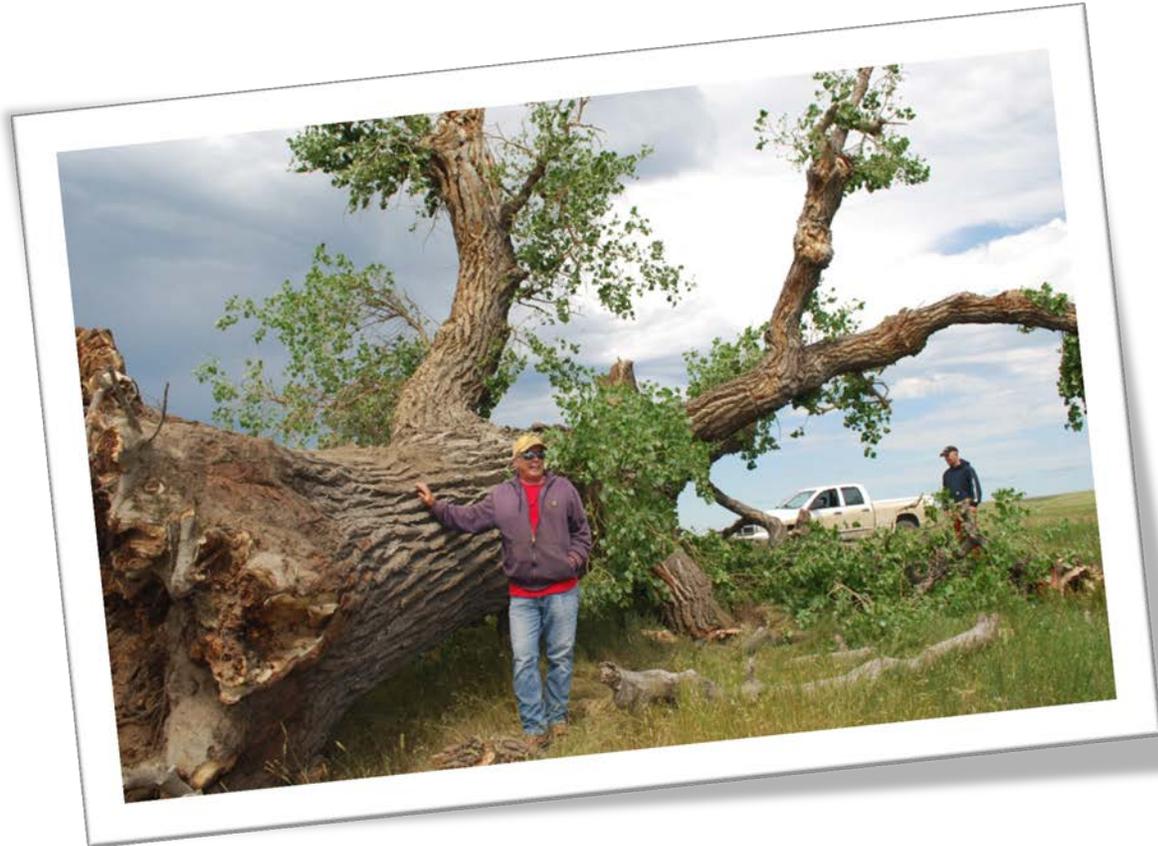
Mark Swank with the well-known cottonwood tree just off the Poplar River that was the picnic site for generations of farm families in the area for 4th of July celebrations. While the tree had some dead on it, there were many live branches left on this beautiful 4 foot in diameter tree. Photo by NWS Glasgow

The tornado then moved across the Poplar River valley. At this point, some photos show it off the ground, but the circulation on the ground may have continued while the visible condensation funnel had to lower itself to the valley bottom. At 447 pm, a farm right on County Road 2042 had the roof peeled off of a well-constructed metal building by rear flank downdraft winds. Wind speeds at this location were estimated at 110 mph. From that farm, they could see the tornado two miles south of them and 13.5 miles east of Montana Highway 13. At this location, 9 power poles were snapped, and irrigation pipes were lifted and moved westward. A large cottonwood tree was also uprooted. Wind speeds were estimated at 100 mph.
